# Transmission Won't Shift?

Operators of some PLS tractors are reporting problems with transmission DO NOT SHIFT lights or transmissions that won't shift. Alternator voltage peaks are a possible cause.

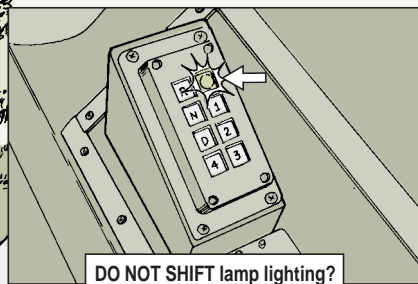
DO NOT SHIFT lamp lighting?

Some PLS tractors, built between Aug 97 and Jun 99 with serial numbers 63479 through 66375, are experiencing voltage peaks on the 200-amp alternator. The peaks show up as DO NOT SHIFT lights on the dashboard, or even as a transmission that won't shift after the engine is started.

**3.** Check to see if the DO NOT SHIFT light goes out. If it does, the alternator is the problem and there's a capacitor installation kit available to fix it.

Contact the Oshkosh Truck Defense Service Department, (800) 235-9151, Ext 2681, to get the free kit.

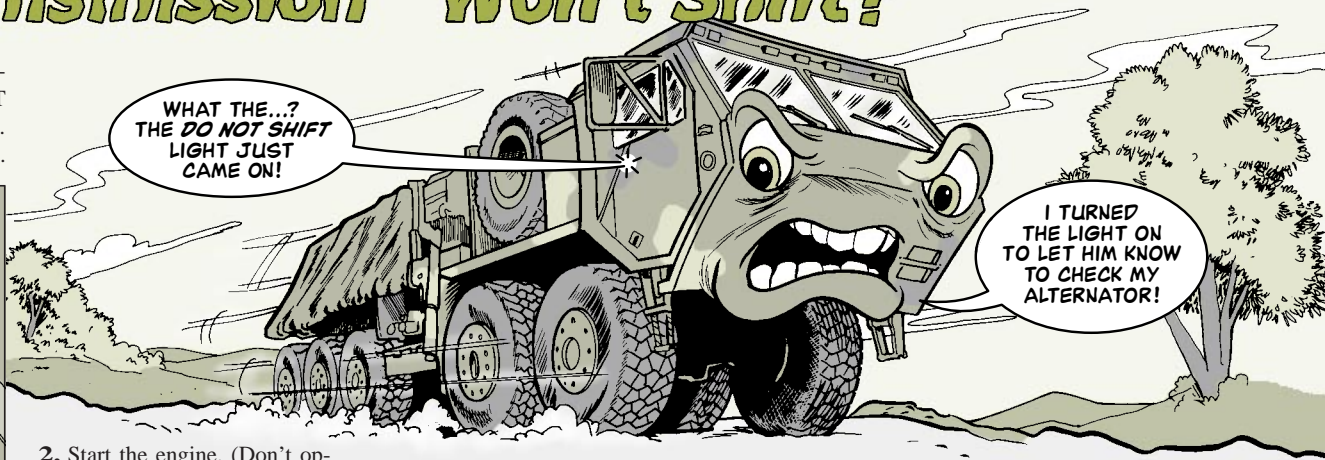
Disconnect regulator connector from alternator

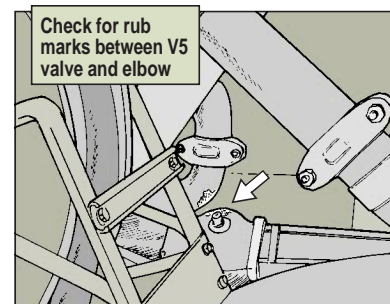
Next time you mechanics have the right-side access cover off your M978-series HEMTT tanker, eyeball the V5 flow valve air actuator and the 90° pipe elbow just above it.

If the two components are touching or if you see wear marks on the pipe where they've rubbed against each other, your tanker is NMC until repairs are made.

The rubbing eventually will put a hole in the elbow, creating a fire hazard and spilling fuel on the ground.

Repair procedures to fix this problem, which first surfaced in the early '90s, are in TACOM Safety-of-Use Message (SOU) 94-07. Contact your local TACOM logistics assistance representative for a copy.
